NBS-IR-78-1498

AFML-TR-78-83

## **FRACTURE OF BRITTLE MATERIALS AT HIGH TEMPERATURE**

TECHNICAL REPORT AFML-TR-78-83

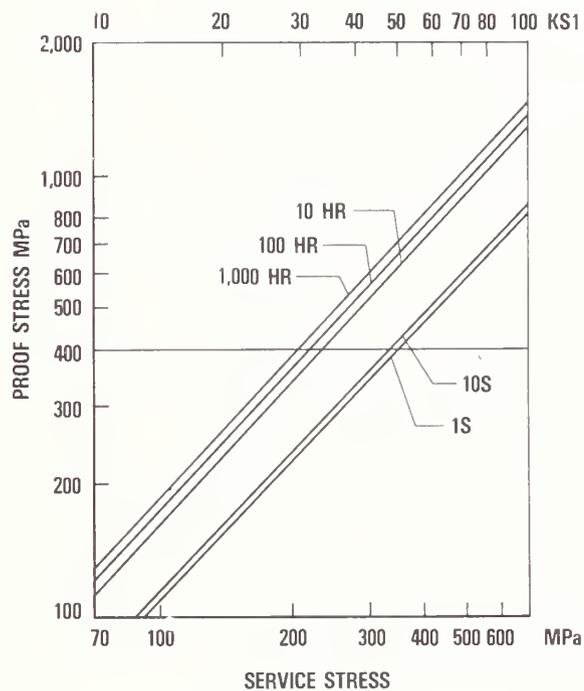
Figure 1. Proof test diagram for hot-pressed silicon nitride NC-132. This diagram is based on crack propagation data obtained in air at 1200°C (Ref. 18).

The theory of proof testing provides a unique relation between the proof test stress, the service stress, and the predicted minimum time to failure in service [5,7]. This relationship can be expressed in design diagrams prepared from crack velocity data. These diagrams can be used by engineers to establish proof test levels for specific materials. In the diagram shown in Figure 1, the proof test stress is selected for the

desired exposure time and the service stress. As a hypothetical example, if 100 hour service at 300 MPa were required, then a proof stress of 560 MPa is determined, from Figure 1, as the stress that would be necessary to assure full design lifetime of the components.

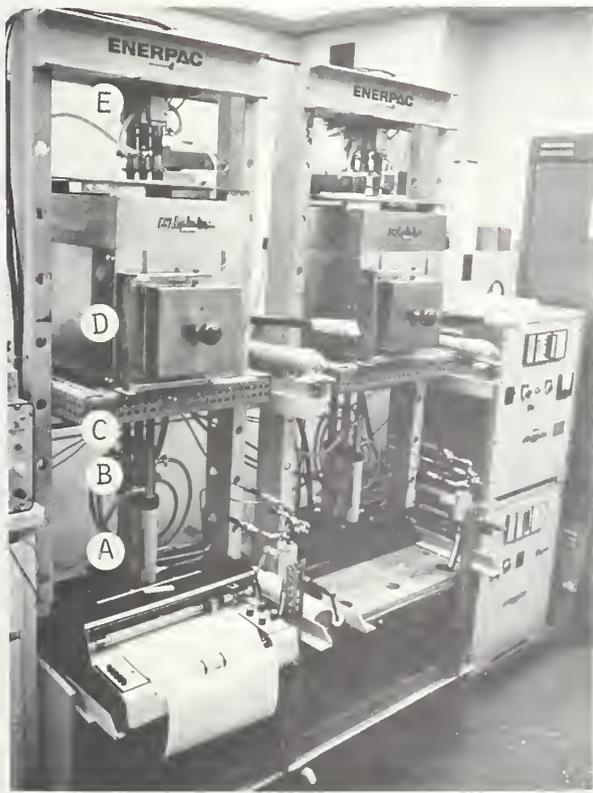
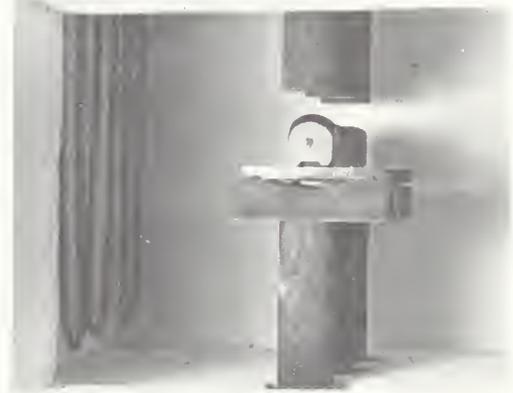
Figure 2. Hydraulic loading apparatus used to test 3 specimens in one furnace (a) furnace and loading arrangements; (b) interior of furnace showing 3 specimens in place.

Most of the experiments were carried out using a standard screw operated testing machine, (the Instron type). However, in order to perform experiments more efficiently, a special hydraulic loading test apparatus was designed and built so that three specimens could be broken independently in one furnace. Two furnaces (D) were set-up as in Figure 2a. Each test apparatus has 3 hydraulic cylinders (A) mounted below the furnace and 3 load cells (E) mounted above the furnace. Silicon carbide rods (C) attached to each load cell and cylinder with a water-cooled fixture (B), extend through the top and bottom of the furnace. Figure 2b shows a set of three test bars in our standard 4-point bend jigs assembled inside the furnace.

The load is applied to each specimen individually and the output is recorded. The loading rate was established by adjusting the oil pressure to obtain a displacement rate which was equivalent to the displacement rate used in the standard machine. The data obtained with this apparatus compared well with that obtained in the standard machine and the results were reproducible.

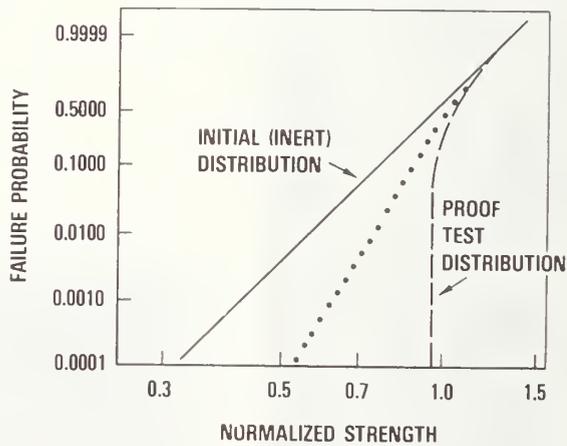
Figure 3. Weibull type probability plot demonstrating the effect of proof testing on strength distribution: - initial inert distribution; --- proof test in an inert environment; ... proof test in an environment in which subcritical crack growth can occur.

this initial inert strength distribution a stress is chosen that will break approximately 50% of the population. When the survivors of the proof test are broken the strength of the surviving specimens should be higher than this proof stress. Thus when these strength values are

ordered and plotted on the Weibull diagram the strengths appear as in the dashed line of the Figure; that is, the strength distribution is truncated. If the proof test survivors are affected by the testing conditions then they will not follow the truncated curve and the strength distribution can fall somewhere between the ideal proof test distribution curve and the initial, inert distribution as shown by the dotted line in Figure 3.

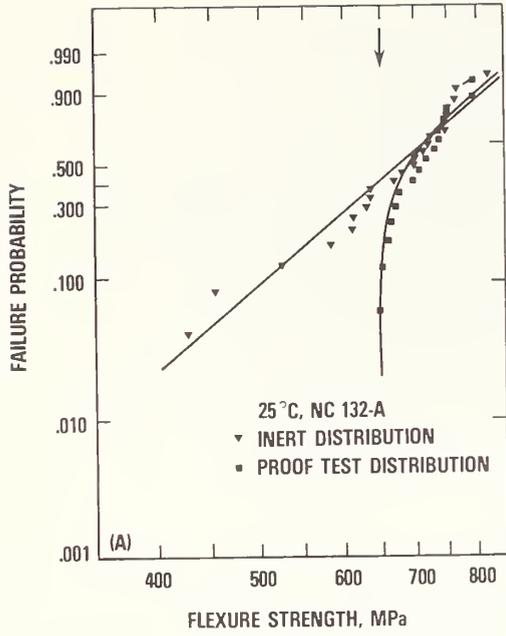
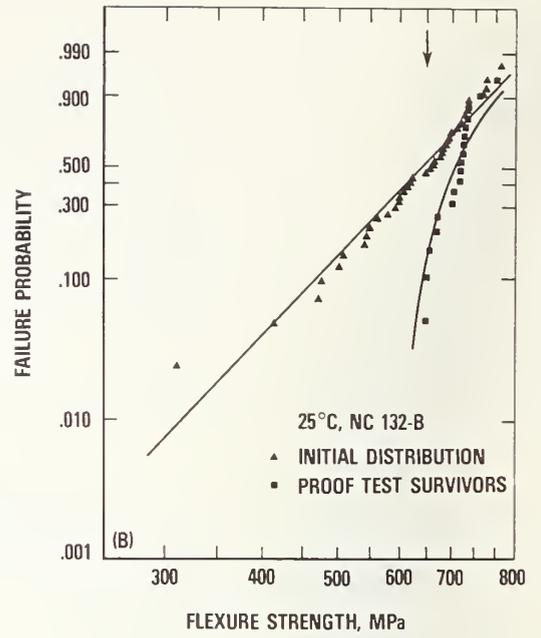
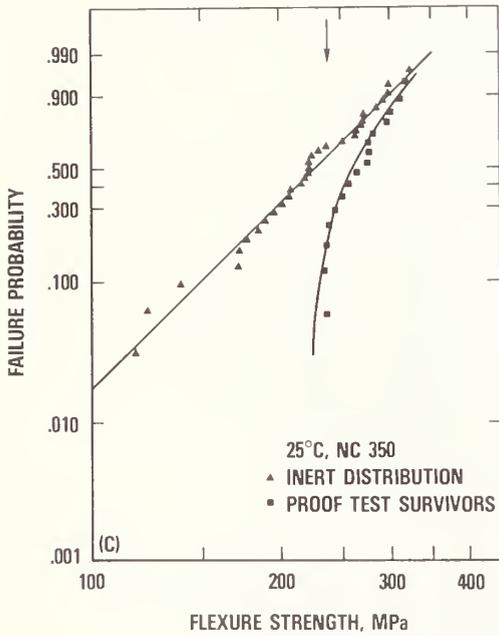
Figure 4. Effect of proof testing on the strength distribution of silicon nitride at 25°C: (A) hot pressed silicon nitride billet A; (B) hot pressed silicon nitride billet B; (C) reaction bonded silicon nitride.

The effect of proof testing on the strength distribution at 25°C is shown in Figure 4A, B for hot pressed silicon nitride and in Figure 4C for reaction bonded silicon nitride. As can be seen in these Weibull plots of the data, proof testing truncates the strength distribution for both types of silicon nitride because the breaking strengths of the survivors were greater than the proof stress. This finding indicates that proof testing can be used to eliminate weak specimens and thus improve the structural reliability of silicon nitride in room temperature applications.

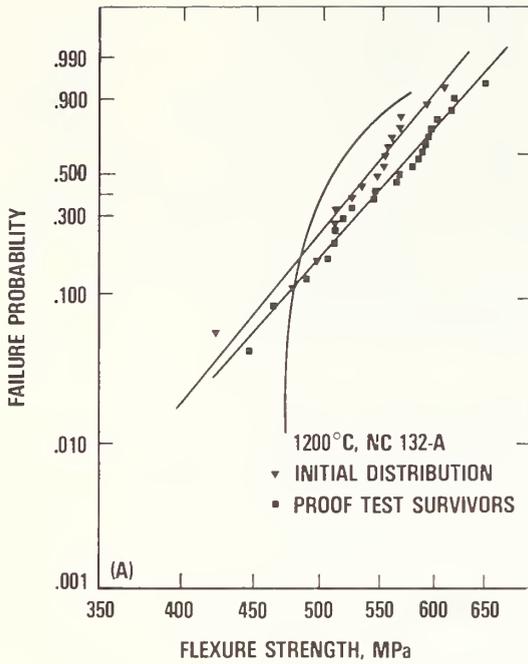
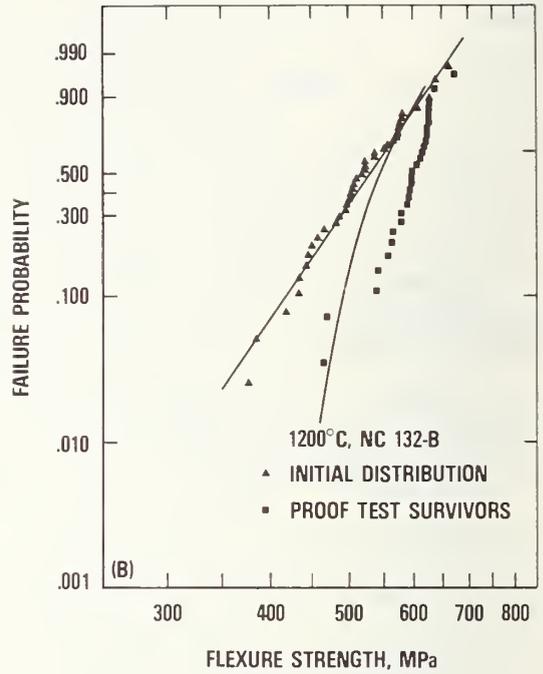
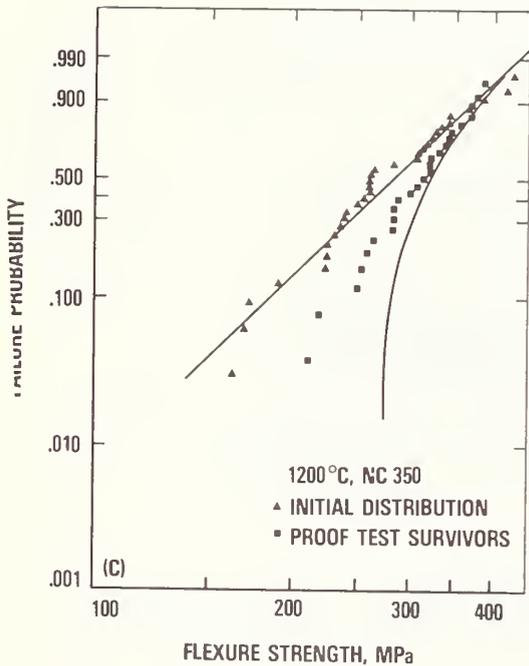
Figure 5. Effect of proof testing on the high temperature (1200°C) strength distribution:  
 (A) hot pressed silicon nitride billet A, proof test at 25°C;  
 (B) hot-pressed silicon nitride billet B, proof test at 1200°C;  
 (C) reaction bonded silicon nitride, proof test at 25°C.  
 Solid curves are predicted strengths after proof test.

the high temperature exposure, then proof testing will not be a viable screening procedure. The results of the tests shown in Figure 5 indicate that specimens behaved differently from theoretical expectations which means that the initial flaw population of the materials was modified by the high temperature exposure. These data show that proof testing will be of doubtful value at the 50% probability level used to obtain the data.

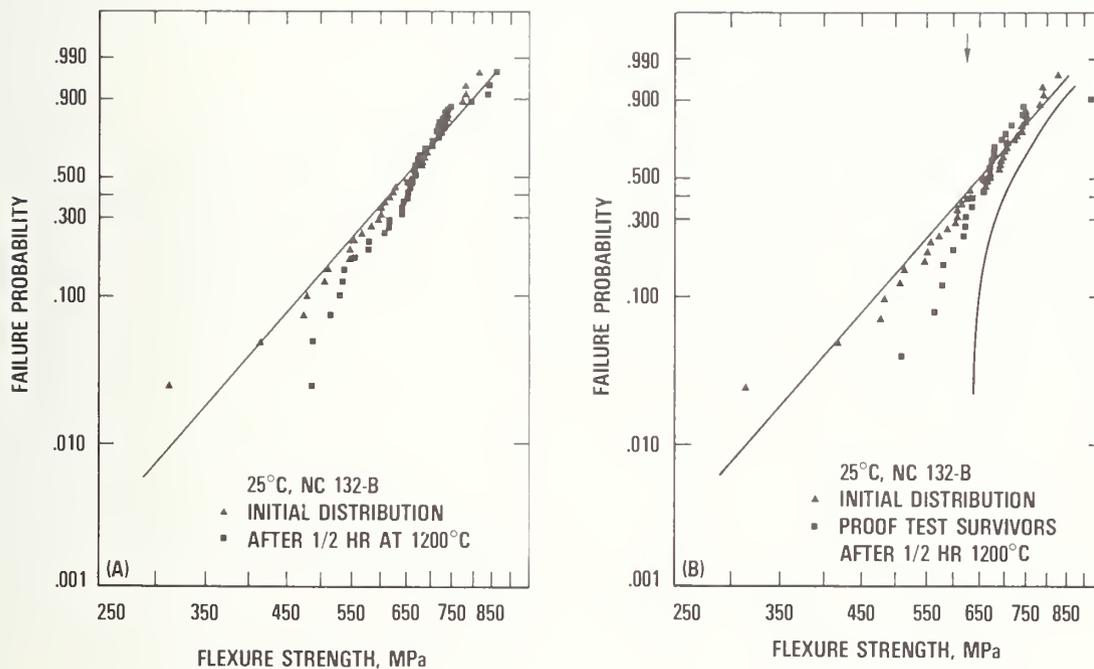
Figure 6. Effect of high temperature exposure on the room temperature strength of hot-pressed silicon nitride, billet B: (A) exposure of as-received specimens; (B) exposure of the survivors of a room temperature proof test. The solid curve in (B) gives the strength distribution after proof testing at room temperature, while the arrow gives the proof test level, 630 MPa.

To test the effect of temperature on the flaw population, a series of exposure experiments was conducted at 1200°C. Specimens were proof-tested before exposure in order to truncate the initial distribution, and other specimens were exposed without proof-testing. Strengths were measured after exposure at room temperature. Figure 6 shows the results

of a 1/2 hour exposure on the room temperature strength of two sets of specimens from billet B, one of which had been truncated prior to exposure. In figure 6A we see that the initial, inert distribution was affected by exposure to high temperatures, in that the specimens broke at somewhat higher loads after exposure. In Figure 6B we note the strength distribution after exposure differs from the truncated distribution, which is given in the Figure by the solid curve. Approximately 50% of the specimens tested broke at loads that were less than the proof-test load. A comparison of Figures 6A and 6B indicates that after exposure, both the normal and truncated populations gave nearly the same distribution. Thus both populations were altered in such a way that the flaw population after exposure was independent of the initial population. A reasonable explanation for this observation is that the initial population of flaws is replaced by one produced by oxidation at 1200°C in air.

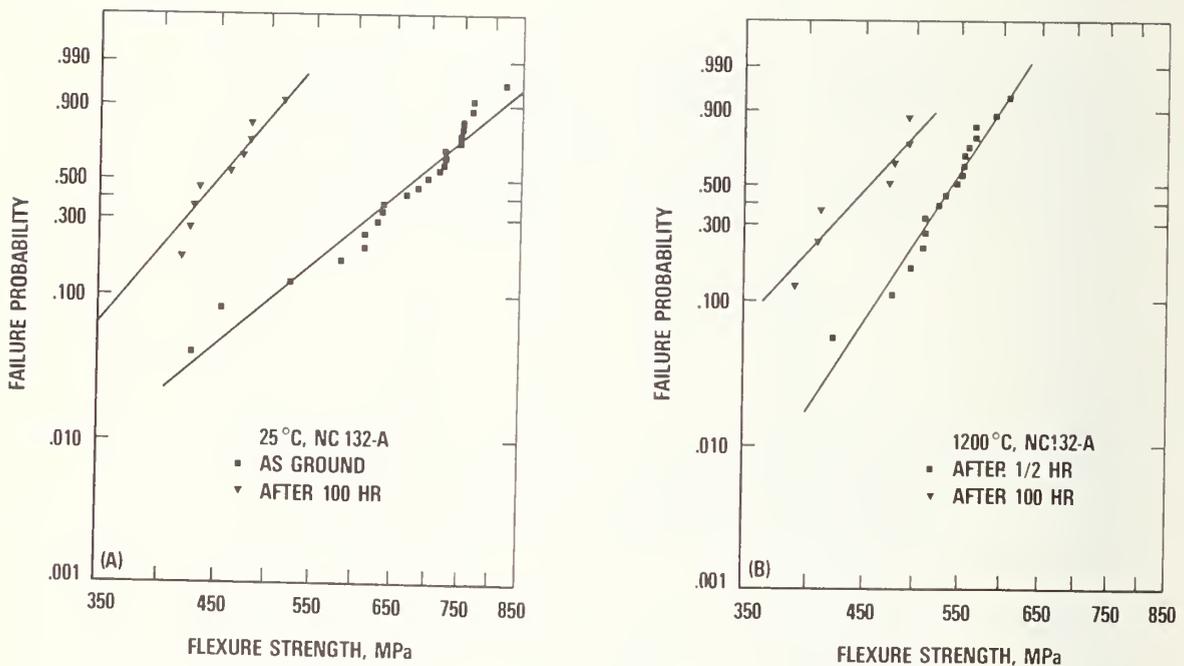
Figure 7. Effect of high temperature exposure in air for 100 hr on the strength of hot-pressed silicon nitride (billet A): (A) strength at 25°C; (B) strength at 1200°C.

The findings obtained in the indentation studies were confirmed in strength studies conducted on specimens that were not indented. Strength measurements on billet A after 100 hours of exposure at 1200°C indicated that the strength at 25°C and 1200°C decreased and the strengths were considerably below the initial (as ground) strengths shown in Figure 7. Thus, flaws generated by high temperature oxidation are far more severe

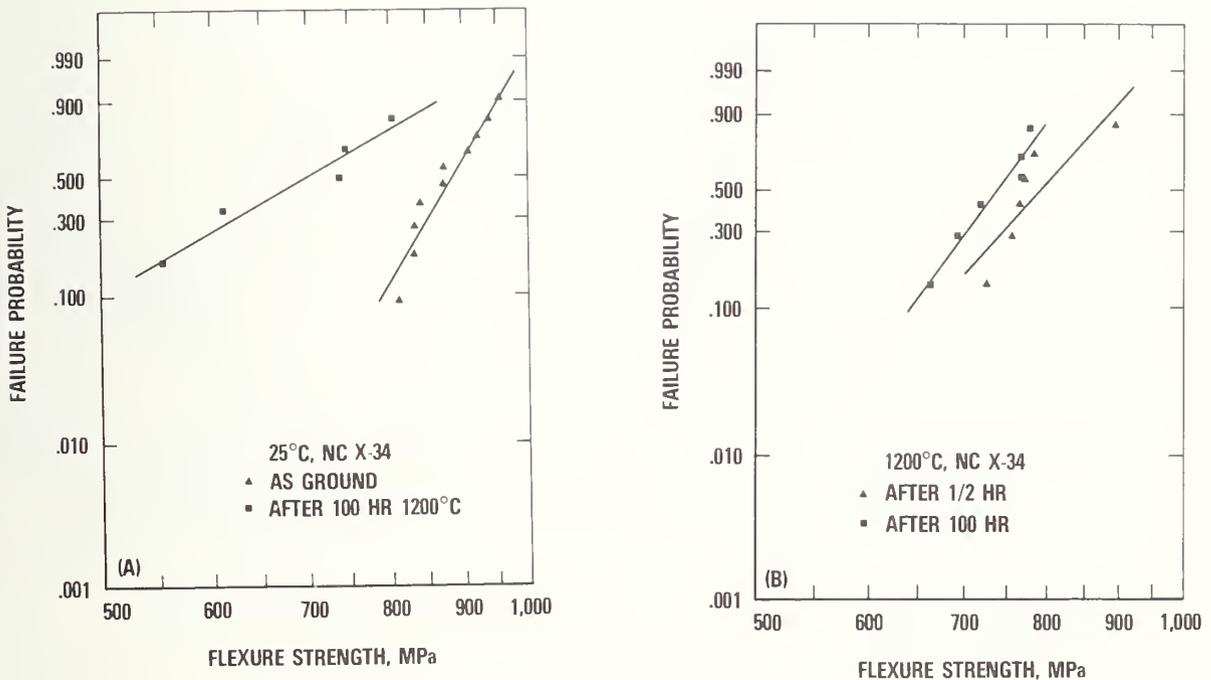
Figure 8. Effect of high temperature exposure for 100 hr on the strength of  $Y_2O_3$  doped silicon nitride: (A) strength at  $25^\circ C$ ; (B) strength at  $1200^\circ C$ .

The strength of the  $Y_2O_3$  doped silicon nitride (NCX34) also degraded after exposure at  $1200^\circ C$ . The data plotted in Figure 8 show that the mean strength at  $25^\circ C$  decreased after 100 hours exposure from 880 MPa to 692 MPa and the Weibull slope decreased from 16.3 to 5.9. This 20% decrease in strength was significantly greater than that observed for billet A. The indentation results in Table 1 show that the indentation was still the effective flaw after 100 hr at  $1200^\circ C$  but was not the effective flaw in specimens broken at  $25^\circ C$  after the same exposure.

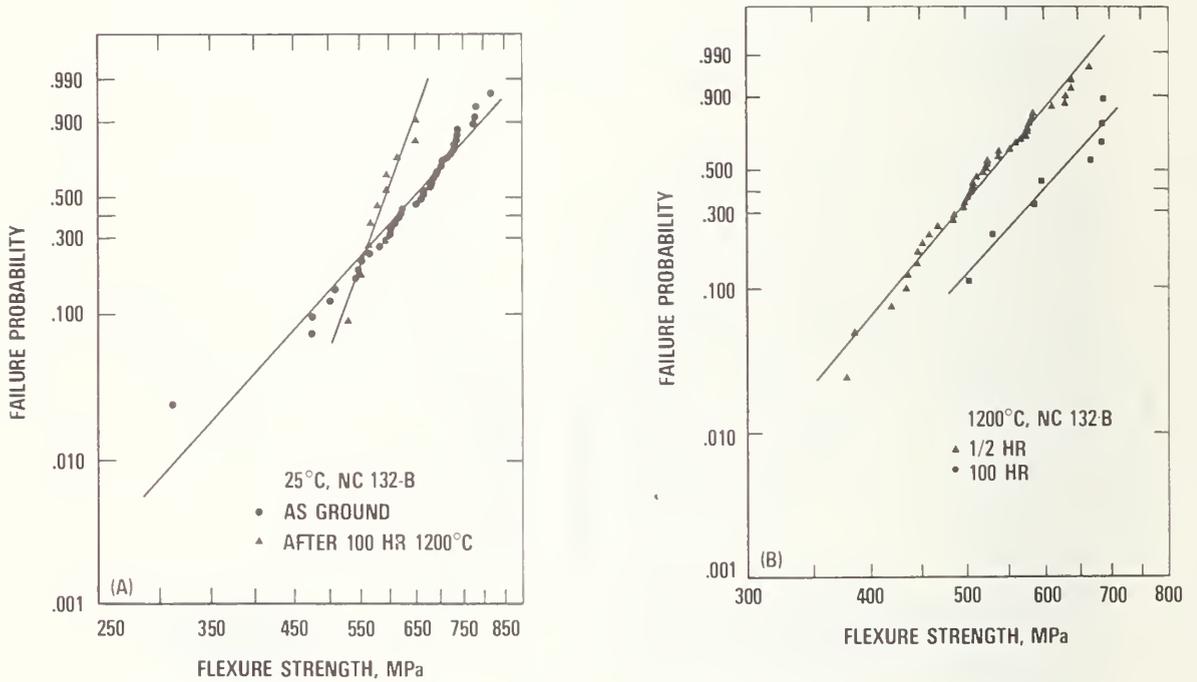
Figure 9. Effect of high temperature exposure for 100 hr on the strength of hot-pressed silicon nitride (billet B): (A) strength at 25°C; (B) strength at 1200°C.

The strength behavior of NC132 billet B differs from that obtained on billet A. Strength measurements at 25°C after 100 hours of exposure to 1200°C, Figure 9a, indicate that the mean strength decreased from 640 MPa to 580 MPa, whereas the Weibull slope increased from 5.9 to 14.4. The net effect of the increase in the Weibull slope is to increase the strength of specimens that fail at low levels of failure probability, which means that large strength impairing flaws are not generated in billet B by high temperature exposure. As a consequence of this behavior,

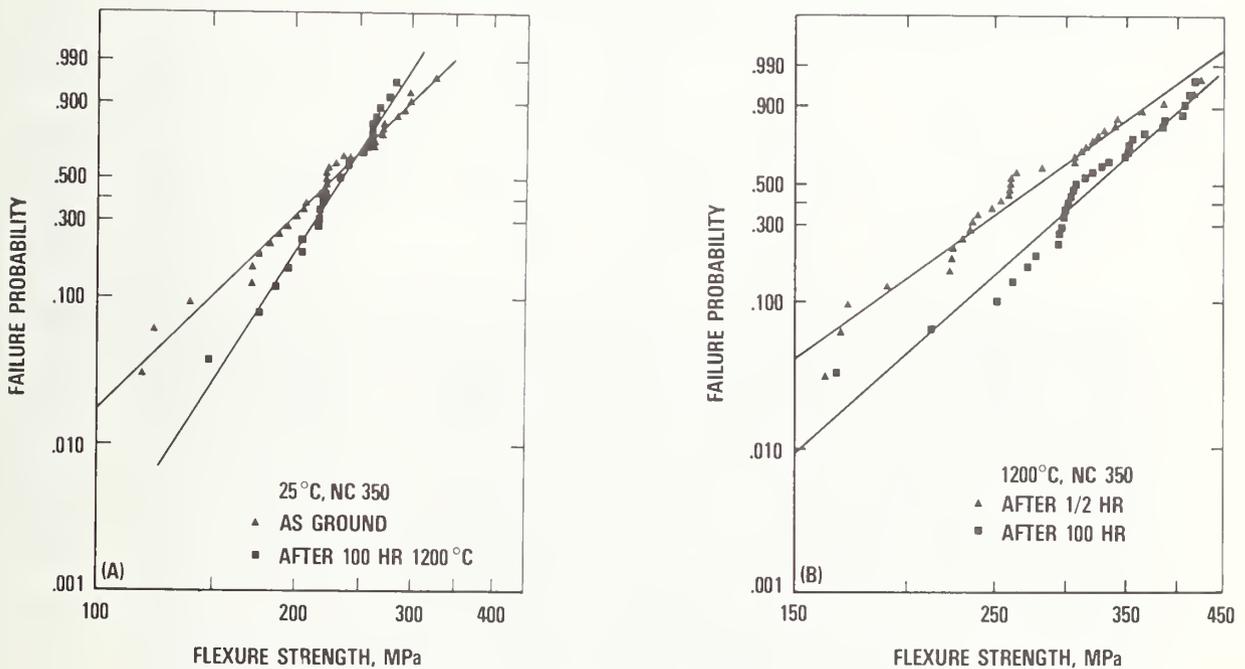
Figure 10. Effect of high temperature on the strength of reaction bonded silicon nitride; 100 hrs at 1200°C: (A) strength at 25°C; (B) strength at 1200°C.

the same as for those obtained on billet B; that is oxidation improved the strength by healing or otherwise reducing the size of large flaws. Therefore, it is concluded that proof testing can be used to improve the performance of components made from reaction bonded material.

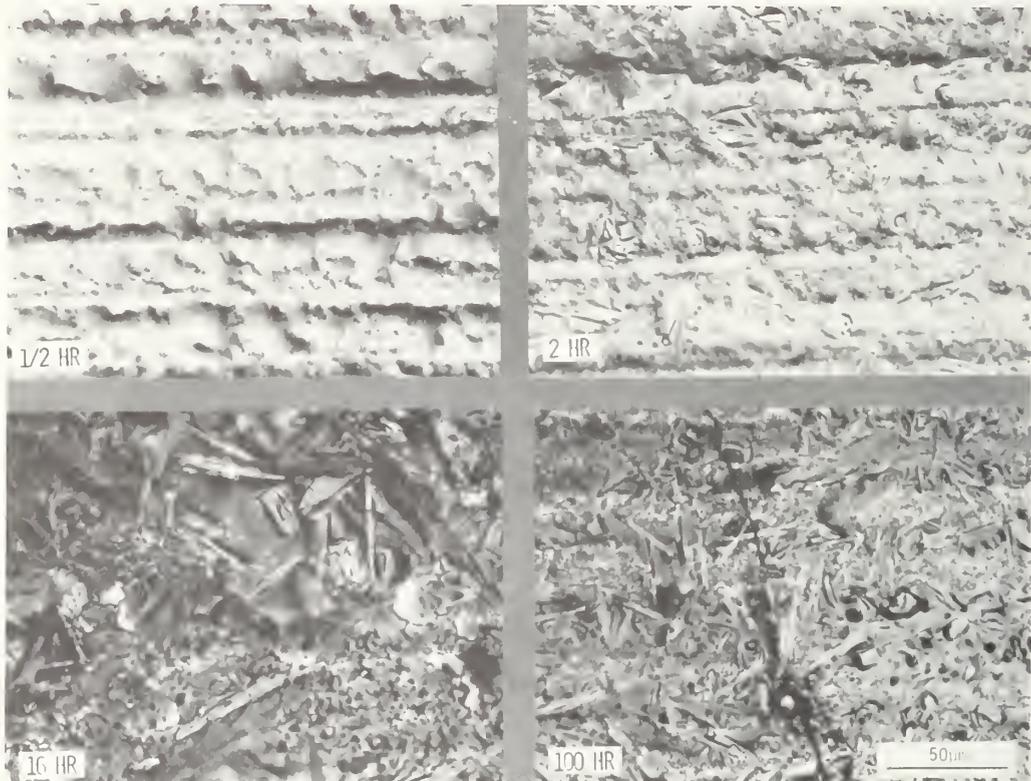
Figure 11. Effect of exposure at 1200°C on the surface structure of hot-pressed silicon nitride: (a) 1/2 hour exposure; (b) 2 hour exposure; (c) 16 hour exposure; (d) 100 hour exposure.

measurements shown in Figure 12. As can be seen from Figure 11, the surface texture changed with time as the oxides formed and after 16 hours the grinding marks were no longer visible. Oxide filled the grinding grooves after 1/2 hour, distinct platelets were seen after 2 hours of oxidation and by the time the components were oxidized for 64 and 100 hours, the specimen was covered with a thick polycrystalline oxide. The oxide film formed on both billet A and billet B specimens after 100 hr exposure had a glassy appearance and had a dispersion over the surface of smooth and uneven mounds and pits, 50-100  $\mu\text{m}$  in diameter.

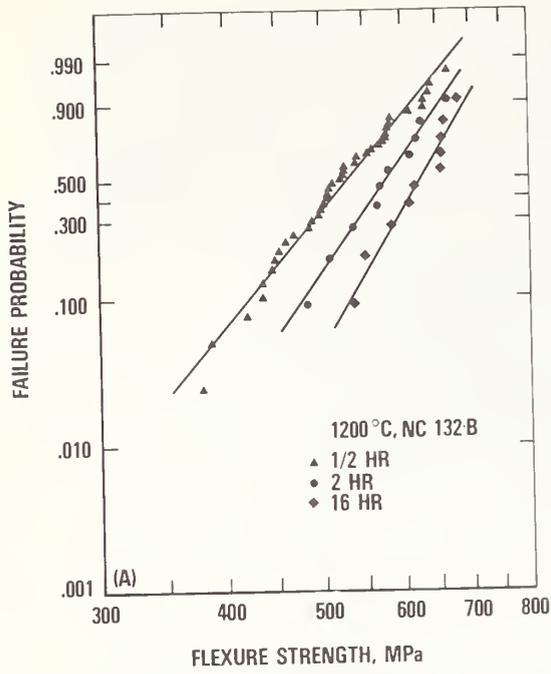
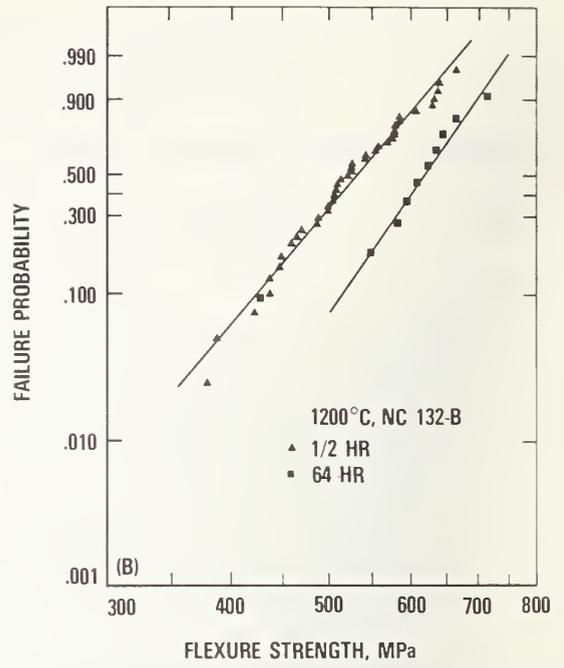
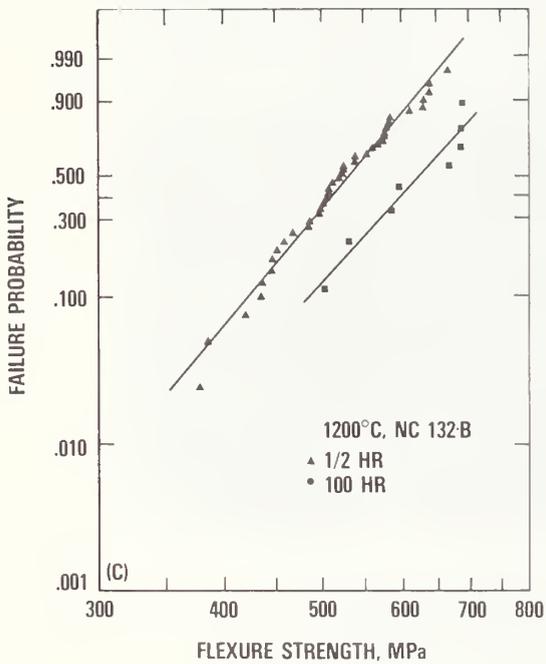
Figure 12. Effect of exposure at 1200°C on the strength of hot-pressed silicon nitride, billet B: (A) 1/2, 2 and 16 hours; (B) 64 hours; (C) 100 hours.

To determine the reason for strength changes in hot pressed silicon nitride, a study of the oxidized surfaces and of the fracture surfaces was conducted using light microscopy, scanning electron microscopy and transmission electron microscopy. Light micrographs shown in Figure 11 present a time sequence of surface oxidation of hot pressed silicon nitride billet B. This time sequence corresponds with the strength

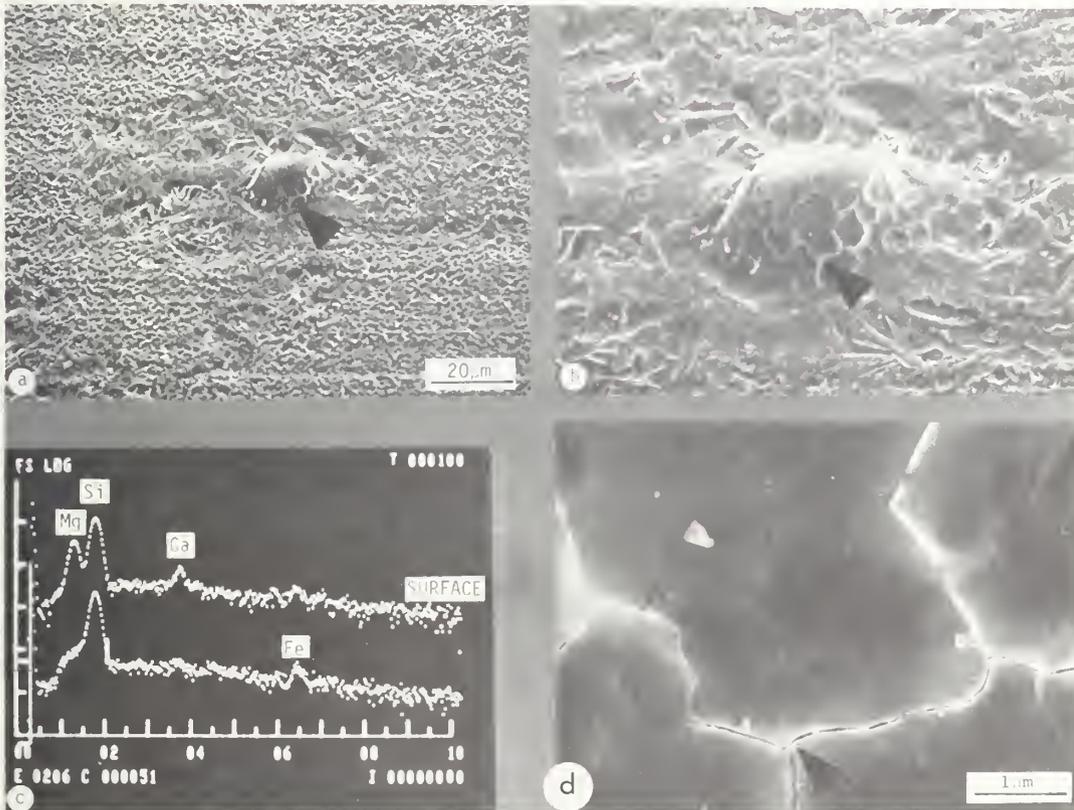
Figure 13. Scanning electron microscopic examination of a pit formed during exposure at 1200°C for 100 hours: (a,b) low magnification photographs; (c) X-ray element analysis of the pit and the nearby surface; (d) details of the cracks on the surface. ▲ indicates same area in a, b and d.

found to be heavily pitted. The pits were  $\sim 50 \mu\text{m}$  in diameter and occurred over all surfaces. By comparing etched and unetched fracture interfaces, it was evident that fracture originated at the surface pits as shown in Figure 14. Specimens from Billet A were more heavily pitted than those from Billet B. Examination of polished cross-sections of the specimens also showed penetration of the oxide into the silicon-nitride along pits as well as along cracks.

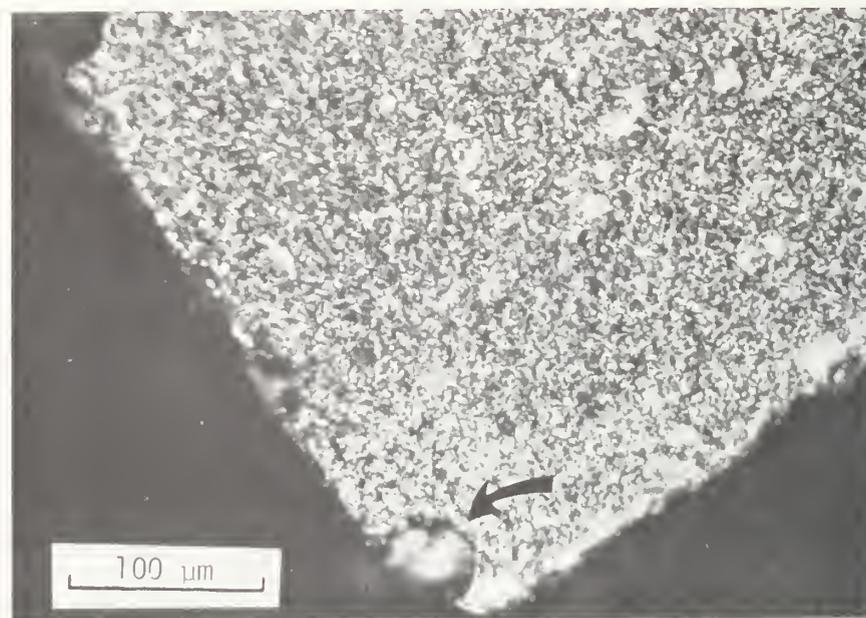
Figure 14. Pit as a fracture source in hot-pressed silicon nitride. The specimen was broken after exposure of 100 hrs at  $1200^{\circ}\text{C}$ . The surface oxide was removed by etching.

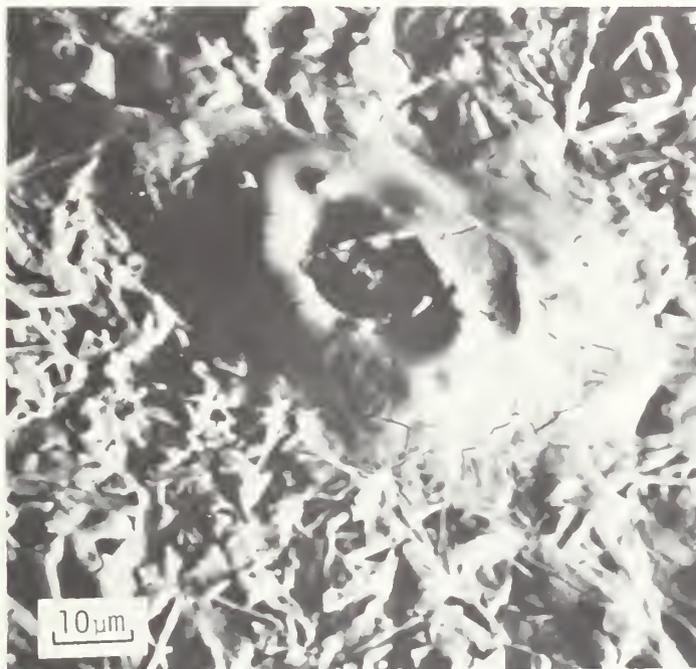
Figure 15. Mound formed during exposure of hot-pressed silicon nitride, billet B, for 100 hrs. at 1200°C. The hole in the center of the mound suggests that gas had issued forth from the mound.

Pits appeared to form under some of the mounds that were observed in the oxide scale. Some mounds have a glassy appearance and as shown in Figure 15, sometimes contained a hole in them. By focusing through these holes [using light microscopy], pits approximately  $50 \mu\text{m}$  in diameter were observed beneath the mounds. The appearance and structure of some mounds suggest that a liquid phase was present at the site of the pit during oxidation. When the indented specimens were examined after 100

occurs when this material is cooled from 1200°C to room temperature before testing is more likely related to microstructural changes than to the oxide-flaw interactions that produced the pits in Figure 15.

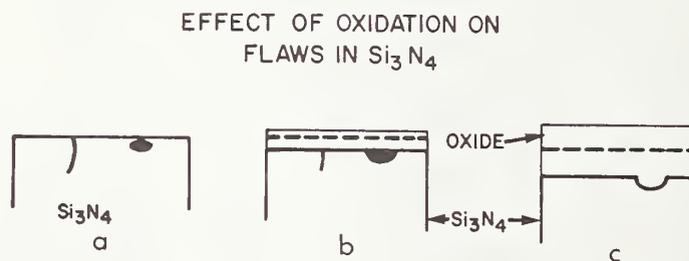
Figure 16. Effect of exposure at  $1200^\circ\text{C}$  on flaws in silicon nitride: (a) surface crack and subsurface inclusion before exposure; (b) after exposure crack size is reduced and subsurface flaw has reacted with the oxide; (c) oxide growth has removed the surface crack and enlarged the subsurface flaw to produce a pit in the silicon nitride.

These microscopy studies on NC132 show that the oxidation is a complex process which involves mass transport of impurities from the matrix, nucleation and growth of new phases within the oxide scale, penetration of the silicon nitride interface along cracks and surface and subsurface inclusions. The diagram in Figure 16 illustrates the interaction observed between the oxide scale and flaws. Two flaws

are indicated: a crack and a subsurface inclusion or pore. Because the oxide scale grows into the matrix, the original, silicon nitride surface

as indicated by the dotted line recedes. The crack is reduced in size and the inclusion or pore interacts with the oxide. If the oxidation continues long enough the crack is removed completely as in (c) and the inclusion or pore is replaced completely by oxide. The severity of the oxidation reaction varies with the material. The effect of the oxide scale on strength degradation can be related to the form of the oxidation process for each material.

It is apparent from the results that the oxidation which occurs during exposure at 1200°C has a significant effect on the strength distribution. The flaw population which controls the strength can be changed in the manner shown in Figure 16. Two types of flaw are considered in Figure 16a, a crack at the surface and an internal flaw which can be an inclusion, a large pore or a crack. When oxidation occurs the crack interfaces oxidize at least as fast as the ground surface and the crack can be blunted. The oxide interface grows into the silicon nitride matrix, removes surface imperfections, and reduces the size of cracks. Internal inclusions can oxidize and change their volume and composition. The mounds in the oxide and pits in the matrix, shown in Figures 14 and 15 respectively, are equivalent to ~50 grain diameters. The accelerated oxidation in areas this size could be related to a concentration of impurities in a mass of incompletely sintered grains or to the rapid oxidation of large tungsten-based inclusions. Such reactions produce an oxide filled pit in the matrix. Until the microstructure is examined more closely, the mode of pit formation cannot be described completely. These oxidation or corrosion pits act as strength limiting flaws in specimens exposed for long times. It is therefore essential to determine why they form and how to control their formation.

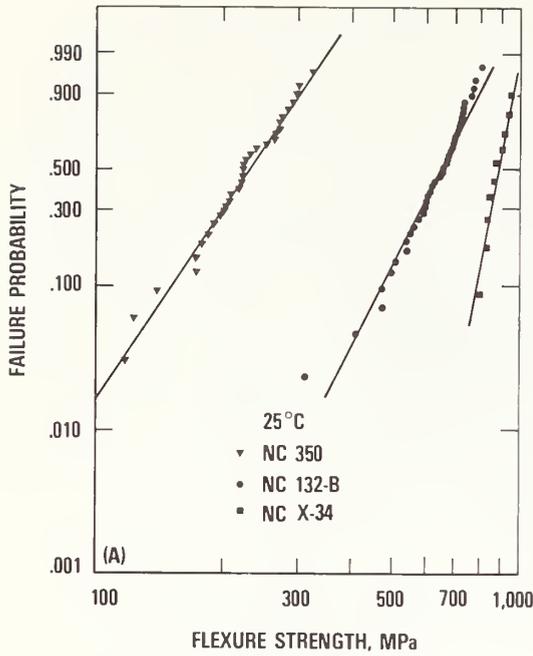
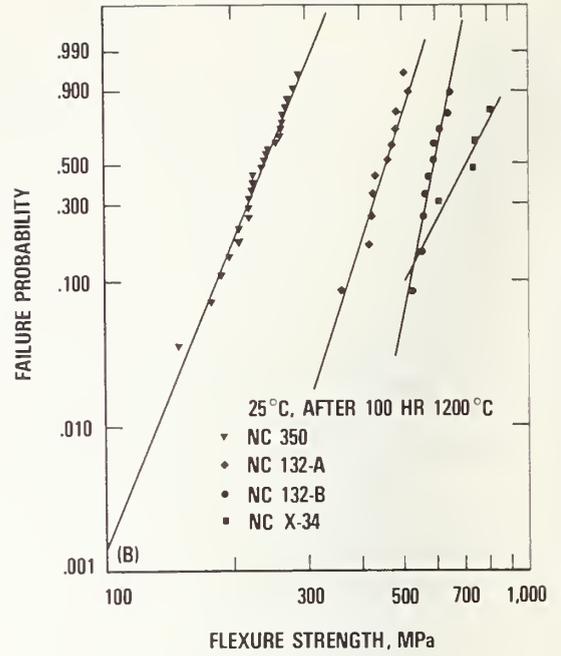
Figure 17. Comparison of strength of reaction bonded and 3 hot-pressed silicon nitride compositions: (a) as-received; (b) after 100 hours exposure at 1200°C.

The effects of exposure at 1200°C on the strength distributions of the four batches of silicon nitride are summarized in Figure 17 and 18. In these figures, it can be seen that the 25°C and the 1200°C strengths of reaction bonded material and billet B of NC-132 are increased by exposure at 1200°C whereas the strengths of the Y<sub>2</sub>O<sub>3</sub> doped-material (NCX-34) and billet A of NC-132 are decreased. These differences are statistically significant and are related to the interaction between the oxide formation and the material. The microstructural differences between the 3 hot-pressed materials are related to the composition. The specific interactions could not be pursued during the present program but should be investigated in order to identify the specific cause of the degradation and to guide further development of materials.

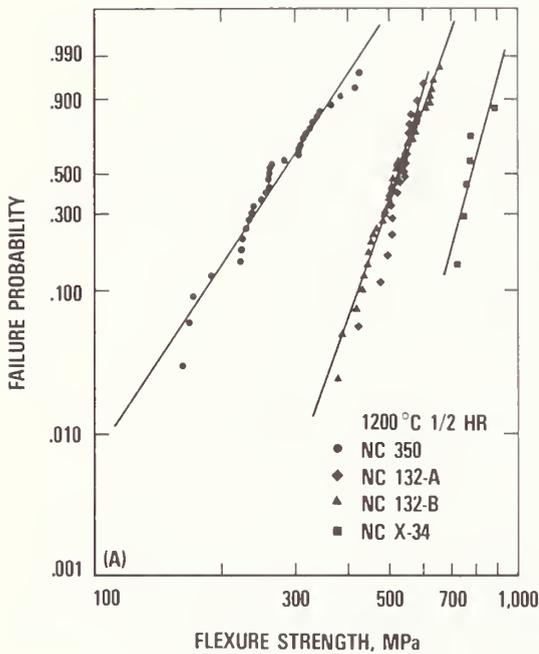
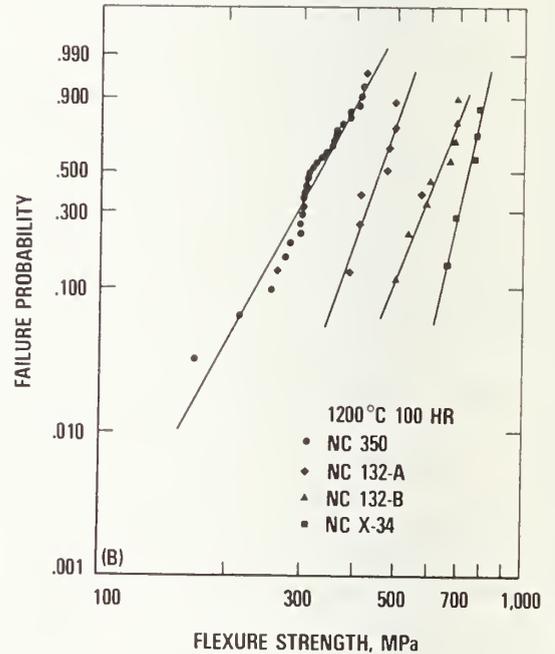
Figure 18. Comparison of the high temperature strength of reaction bonded and 3 hot-pressed composition of silicon nitride: (a) after 1/2 hour exposure; (b) after 100 hours exposure at 1200°C.
